## Pre-Purchase Building Report

xxx Sample Street Samplton

# **Confidential Inspection Report**

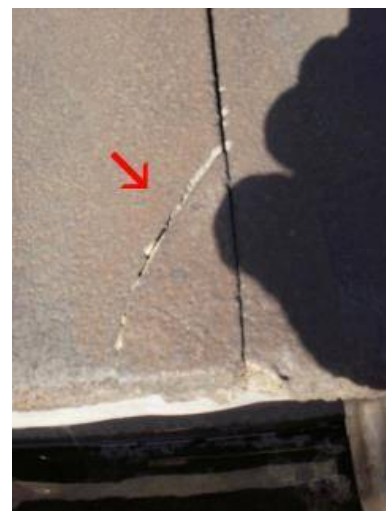
The overall condition of the roof coverings is fair. A small number of cracked roof tiles were noted and should be replaced.

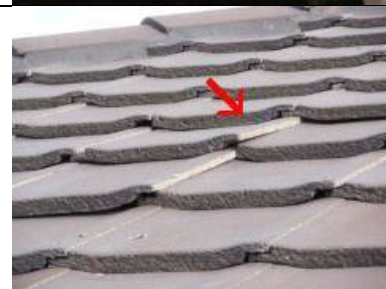
**Photo 2:**

Some roofing tiles have slipped or moved, repairs are required to help prevent water penetration.

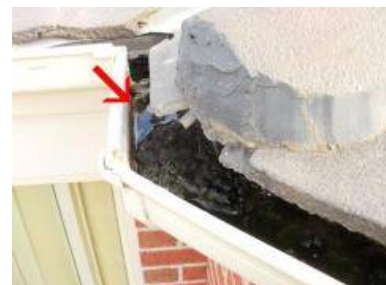
Appear to be in serviceable condition. Water is ponding in the gutters and they require realigning.

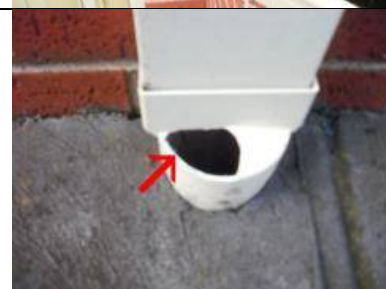
Some stormwater fittings are damaged and require repairs.

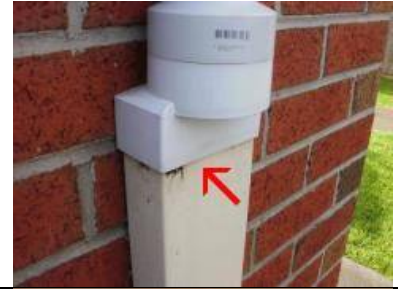
A down pipe rain water diverter has been installed poorly, this type of installation will allow the water to escape the down pipe. Repairs are required by a licensed plumber.

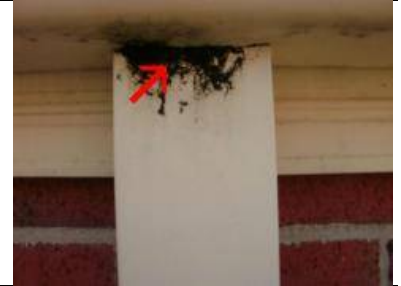
**Photo 2:**

Downpipes are leaking at there bends or joints maintenance is required.

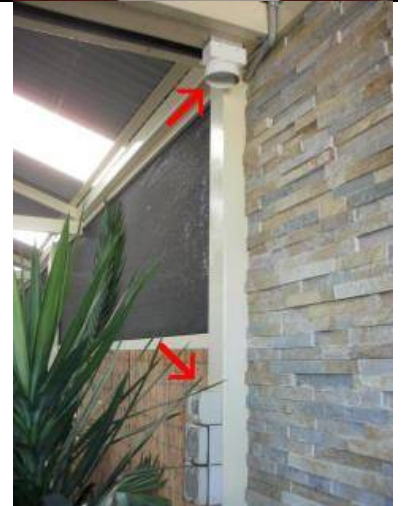
**Photo 3:**

Some downpipes appear to be missing. These should be installed. The missing downpipe is directly above weather proof power points that have been fitted to steel posts, if water was to penetrate this points it could cause electrocution, We strongly recommend that this down pipe be installed at you earliest convenience.

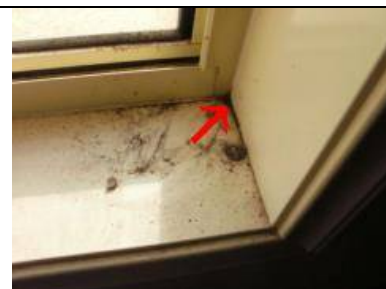
window sills framing show water staining and swelling where the water has penetrated the framing or through condensation off the glass, these windows should be monitored during rain fall and on cold days, further investigation is required. Mould is present to the window frames, mould is very dangerous to your health and may cause respiratory problems. We strongly suggest that the mould is removed and monitored. The cause of mould in this circumstance is generally caused from lack of air movement due to a number of reasons, the obvious one is the heavy window drapes. We suggest that during colder days when heating is used you should check to see how much condensation build up is on the windows then you can plan the appropriate step to take.

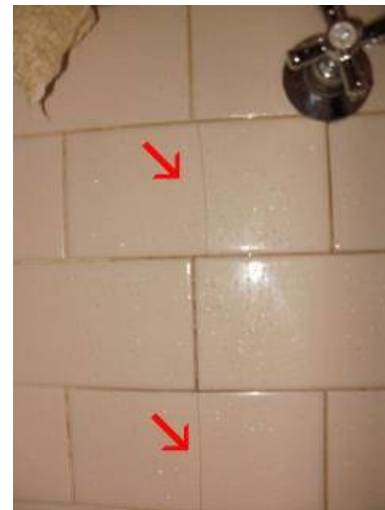
Some cracked tiles were noted in this area. These will require replacement.

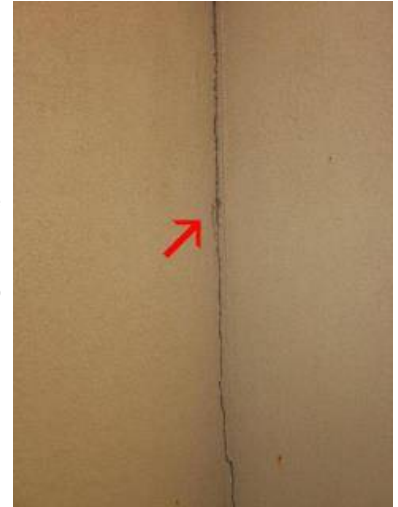
The condition of the walls is generally fair. Cracks are evident to brickwork or render. Visible cracking appears minor. Periodic maintenance may be required and any additional movement should be referred to a Structural Engineer to investigate. The area where cracked brickwork or render was noted is listed below. The Cracks have been classed as a category 2 as listed under structural defects clause 8 Item 4. Cracking to the north west facing internal garage corner appears to be caused by a poorly finished control joint, repairs will be required but does not appear to be of a structural concern. Damaged render was also note at the front door step, repairs will be required.

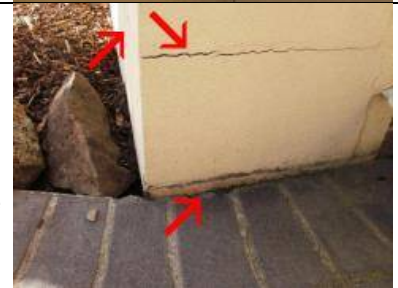
**Photo 2**

The condition of the walls is generally fair. Cracks are evident to brickwork or render. Visible cracking appears minor. Periodic maintenance may be required and any additional movement should be referred to a Structural Engineer to investigate. The area where cracked brickwork or render was noted is listed below. The Cracks have been classed as a category 2 as listed under structural defects clause 8 Item 4. Cracking to the north west corner of the property appears to be caused by a number of reasons, firstly poorly finished control joint was noted along with poorly finish concrete that did not appear to have a separation control strip of foam between the bricks and concrete paving, during ground movement the paving and house will move at different times due to load, this will place pressure against the bricks causing movement and cracking. We recommend that if movement continues you contact a licensed builder/engineer for further comment.

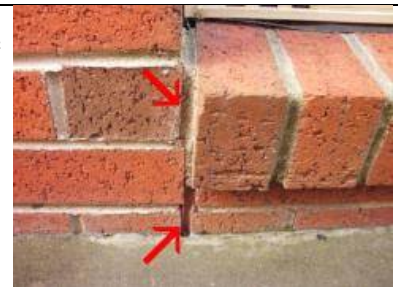
Some expansion joints have been finished poorly and do not continued to the full extent of the joint, if cracking is noted repairs to these expansions will require repairs.

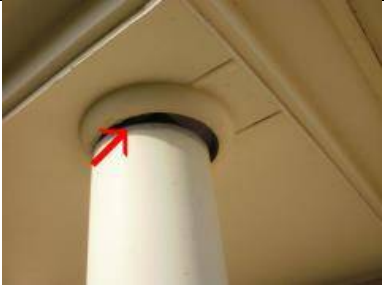
Position/Location:	Front.
Construction & Condition:	Under existing house framing and stands in Fair condition.
Defects or Maintenance Items:	The architectural columns have moved and require repairs.

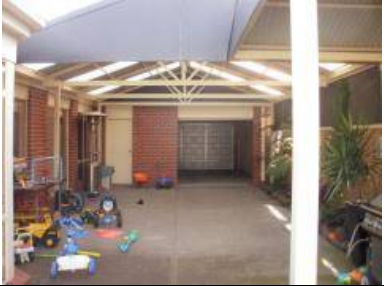
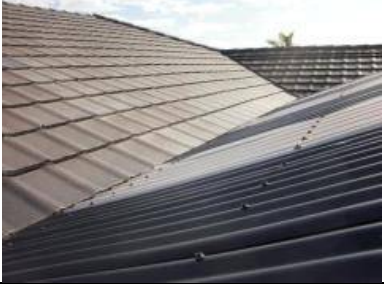
Position/Location:	Left hand side elevation.
Construction & Condition:	Constructed from metal. The general condition of this structure is good. <b>Please check with the local council building department that a building permit is in place for the construction of the pergola.</b>
Defects or Maintenance Items:	The pergola roofing has been partly directed into the existing house guttering. We strongly suggest that you contact a plumber to calculate the amount of rainwater that one 100 x 50 downpipe can service as you maybe required to up size the down pipe or add an extra one to cope with extra rainwater.

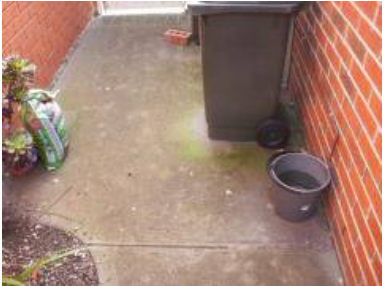
Type & Condition:	The building is constructed on a concrete slab. The footings appear to be generally sound. Concrete paving has been placed from neighboring foundations to your foundation, this may limit the amount of movement and cause unwanted cracking. We recommend that this area is monitored.
-------------------	--

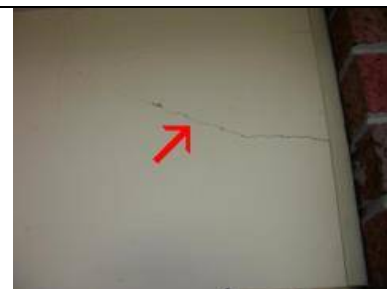
The infill above the rear door is lined with fiber cement sheeting. The overall condition of the eaves lining is fair. Some linings are cracked and require replacing or maintenance.

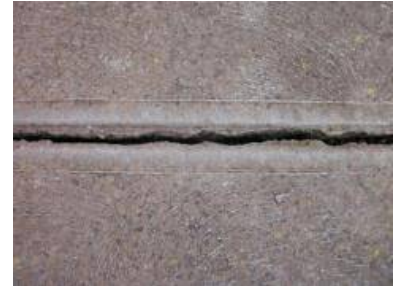
There is no control joint between brickwork and paving, in unstable weather conditions this can cause damage to structure as it limits the amount of movement. The concrete paths/paved areas have some visible cracking consistent with lack of wire reinforcement, that should be monitored for further movement.

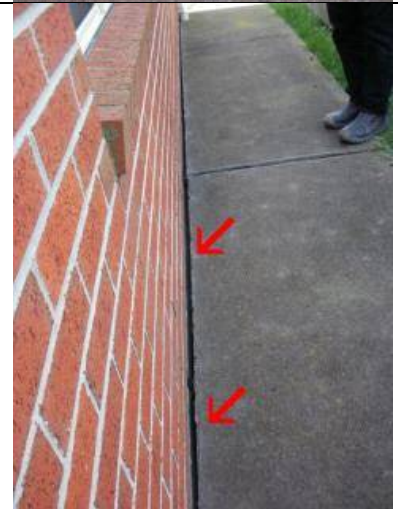
**Photo 2**

The paving at the rear of the house has moved leaving a big gap between the paving and house foundation, this gap will allow rainwater to run down the brick wall and pond against the foundation. The paving will not allow the ground to dry beneath causing ground movement. We suggest that this gap is sealed with a silicon based product to still allow movement.

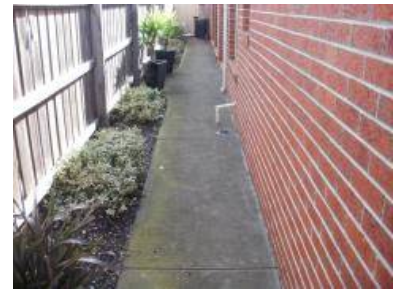
The drainage at the right & Left hand side of the property is inadequate. Drains should be installed at the right side to divert seepage and surface runoff water away from the house. The drains should be connected to the existing stormwater drainage system.
