## **Final/Handover Building Report**

# **Confidential Inspection Report**

Address: Sample

Prepared by: BUILT RITE INSPECTIONS  
1300 551 636

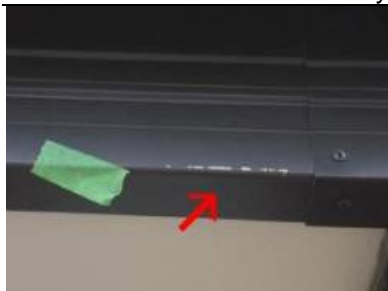
The colourbond fascia and or gutter to the dwelling has been damaged during construction. There are areas that have been scratched; All must be made as new prior to handover.

Please note that the supplier web site on the care and maintenance of gutters clearly states that touch up paint is not to be used when rectifying these types of defects. BlueScope Steel does not recommend the use of touch up paints on COLORBOND® steel. The manufacturing process that gives COLORBOND® steel its colour and gloss retention properties means that the surface weathers differently to air drying paint. After weathering, the areas which have been touched up will look different and can leave a blotchy look. Damaged areas will need to be replaced.

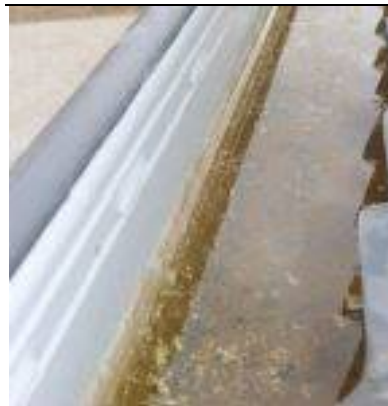
The gutters are currently holding more than 10mm of water which is outside the allowable level. We recommend that the gutters are relevelled by a licensed plumber to obtain the required fall to the gutters outlets.

Gutters are defective if they retain a depth of more than 10 mm of water.

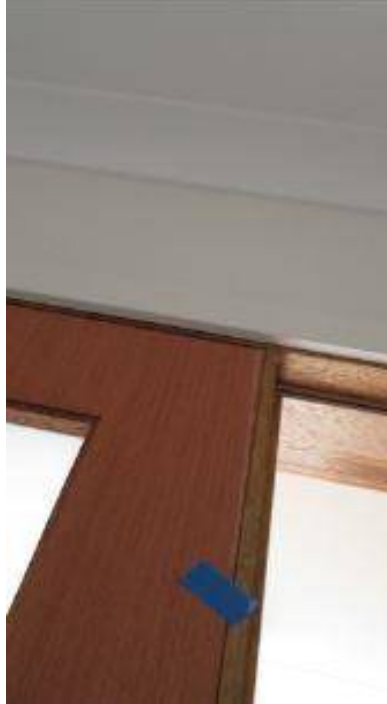
The gap around the door is not consistent and varies from 3mm to 0mm, the door on the hinge side is hinge bound meaning there is no or very little gap, the door will require adjusting to give a consistent 2mm gap around the opening.

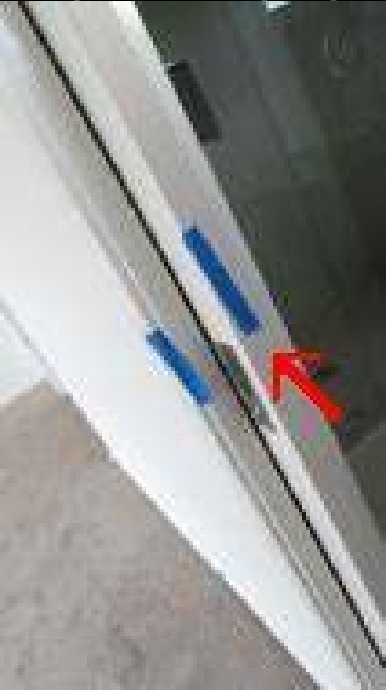
General condition of area:	This area is generally in good condition.
Room Location:	Adjacent to hall.
Ceiling Condition:	The condition of the ceilings is generally good.
Internal Walls Condition:	The condition of the walls is generally fair. Some paint touch ups are required. All areas that require paint touch ups have been marked up with Blue tape.
Built in Cupboard	The condition of the built-in wardrobes is generally good.
Windows Condition:	The condition of the windows is generally good.
Doors Condition:	Paint touchups on the door are required. The areas requiring touchups have been marked with blue tape.

Paintwork is defective if the application has blemishes such as paint runs, paint sags, wrinkling, dust, bare or starved painted areas, colour variations, surface cracks, irregular and coarse brush marks, sanding marks, blistering, non-uniformity of gloss level and other irregularities in the surface that are visible from a normal viewing position. Paintwork is defective if the application results in excessive over-painting of fittings, trims, skirtings, architraves, glazing and other finished edges.

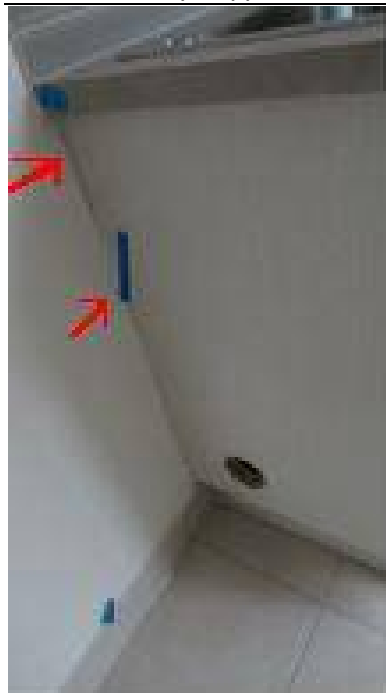
The tub and taps appear serviceable. Caulking around the trough is required.

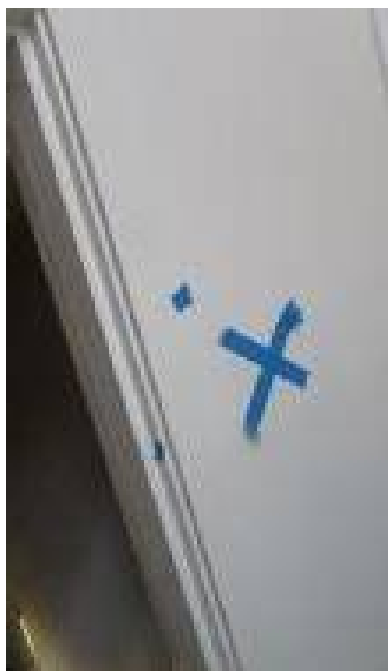
The condition of the walls is generally fair. Some paint touch ups are required. All areas that require paint touch ups have been marked up with Blue tape.

Paintwork is defective if the application has blemishes such as paint runs, paint sags, wrinkling, dust, bare or starved painted areas, colour variations, surface cracks, irregular and coarse brush marks, sanding marks, blistering, non-uniformity of gloss level and other irregularities in the surface that are visible from a normal viewing position. Paintwork is defective if the application results in excessive over-painting of fittings, trims, skirtings, architraves, glazing and other finished edges.

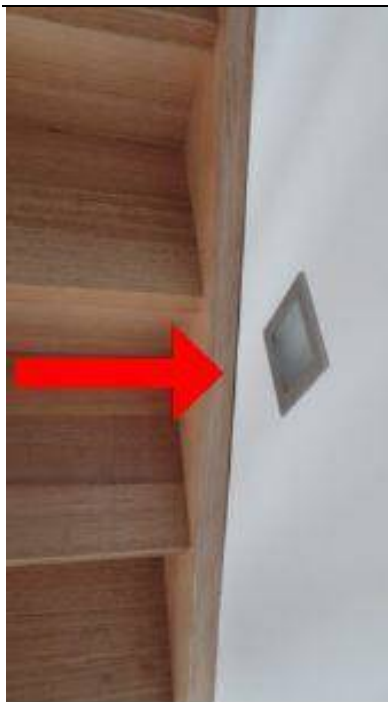
The stairs are constructed primarily from timber. The overall condition of the stairs is good. The gap between the timber stringer and wall board should be quaded with a timber bead or sealed with a silicon based product.

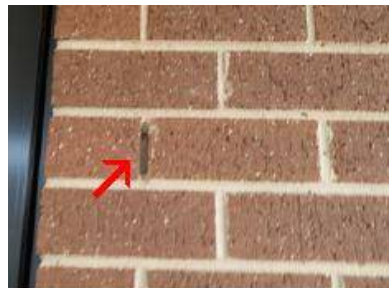
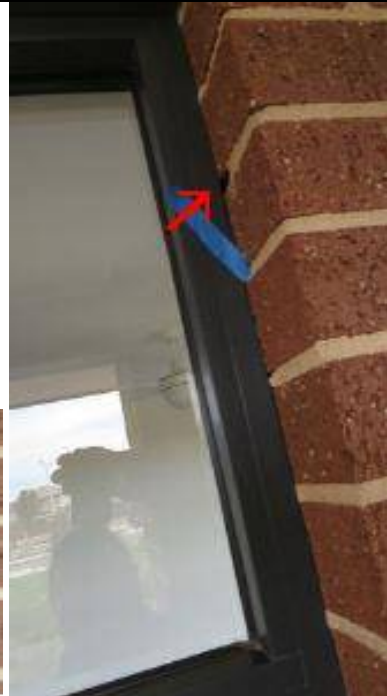
Gaps along side windows will require caulking to help prevent water penetration and wind blow dust.

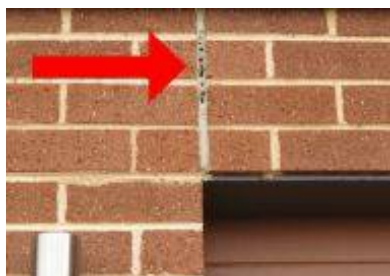
The expansion joint has been poorly filled with silicon and requires repairs. Location front above garage door.
