## Timber Pest Report

XX Sample Street Samplton

# **Confidential Inspection Report**

# VISUAL TIMBER PEST INSPECTION REPORT

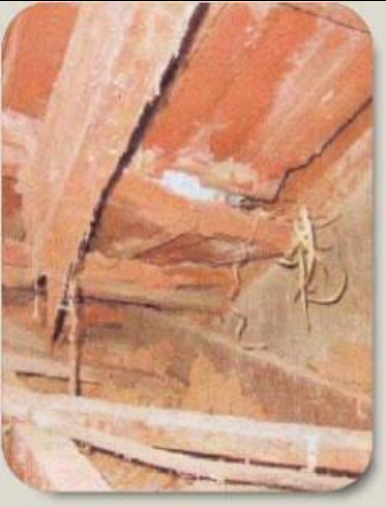
**Termite Activity** Yes - Inspection revealed currently active termites within this area including but not necessarily limited to the following timbers and the areas listed below.  
*Coptotermes* spp.

Rafters: Tile battens:

Lounge room:

Visible timber damage appears severe however, we are not builders and this is not to be considered a builder's opinion. Refer to the definitions section of this report - Section 1.6 - Timber Damage.

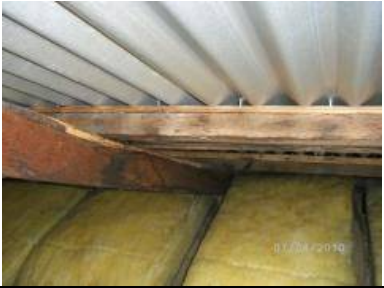
Evidence of Lyctus borer was found. Lyctus borer is not considered to be a significant pest of timber and as the damage is confined to the sapwood content of hardwood timbers, no treatment is required in respect of this borer. Lyctus borer damage was noted to the following timber(s)/area(s).

Various roofing timbers:  
Various areas of the roof void:

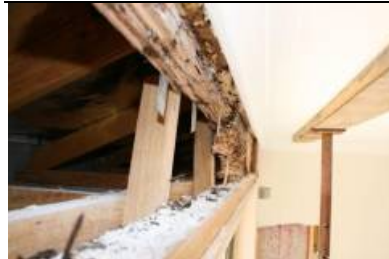
**Photo 2:**

Wall frame timbers: Window frame timbers:

Sever window support damage.

Lounge room:

Visible timber damage appears severe however, we are not builders and this is not to be considered a builder's opinion. Refer to the definitions section of this report - Section 1.6 - Timber Damage.

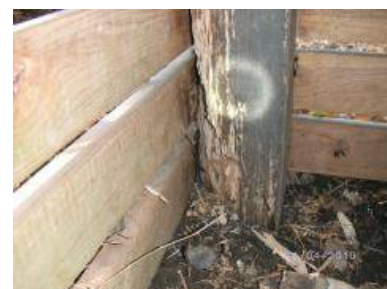
**Description** Evidence of Lyctus borer was found. Lyctus borer is not considered to be a significant pest of timber and as the damage is confined to the sapwood content of hardwood timbers, no treatment is required in respect of this borer. Lyctus borer damage was noted to the following timber(s)/area(s).

**Affected subfloor timbers** Various subfloor timbers:

**Below the following location or area** Various areas of the subfloor:

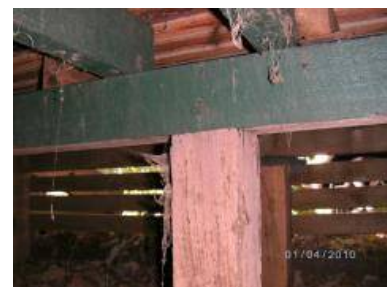
**Description** We note that although antcapping is present to some areas, it is missing or deficient in other areas. The purpose of ant capping is to reduce the risk of concealed termite attack. Ant capping should be repaired or installed where possible. If this is not possible, regular inspections should be carried out. Missing, damaged or poor termite ant capping increase the risk of termite infestation.

We recommend the removal of loose timbers from the underfloor area as these predispose the property to termite attack.

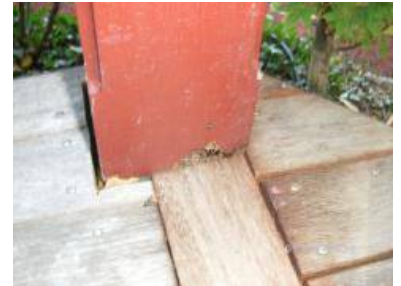
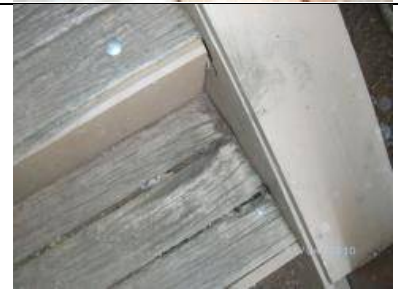
<b>Description</b>	Yes - Wood decay damage was noted to the following timbers/areas.
--------------------	---

<b>Affected external timbers</b>	Steps/stair timbers: Verandah posts.
----------------------------------	--------------------------------------

<b>Location/area</b>	Rear section of the property:
<b>Severity</b>	Visible timber damage appears moderate to severe however, we are not builders and this is not to be considered a builder's opinion. Refer to the definitions section of this report - Section 1.6 - Timber Damage.

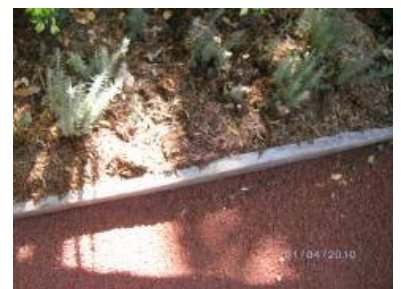
<b>Description</b>	Untreated landscaping timbers should be removed or replaced with a treated timber or non timber alternative, as they are conducive to a timber pest attack and may also contain unseen timber pests. If replaced with timber, ensure appropriate durability rating for external use.
--------------------	--
