## Pre-Purchase Building Report

xxx Sample Street Samplton

# **Confidential Inspection Report**

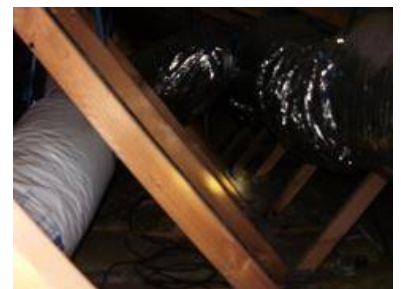
**Roof Framing:****Roof Supports - Type and Condition:**

The truss roof system appears to be adequate for the roof covering.

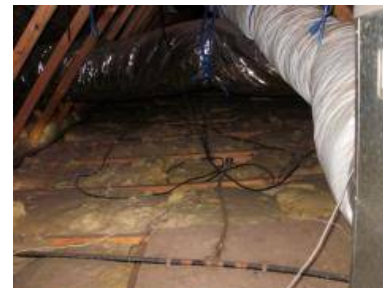
**Insulation & Sarking:****Insulation Status:**

The insulation to the ceiling cavity is ok.

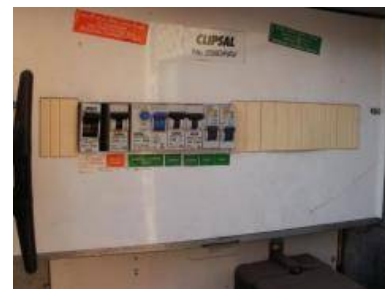
Smoke detectors are fitted, however, the positioning, operation or adequacy was not tested and is not commented on. Earth leakage and circuit breaker are fitted and serviceable.
