## **Final/Handover Building Report**

# **Confidential Inspection Report**

Address: Sample

Prepared by: BUILT RITE INSPECTIONS  
1300 551 636

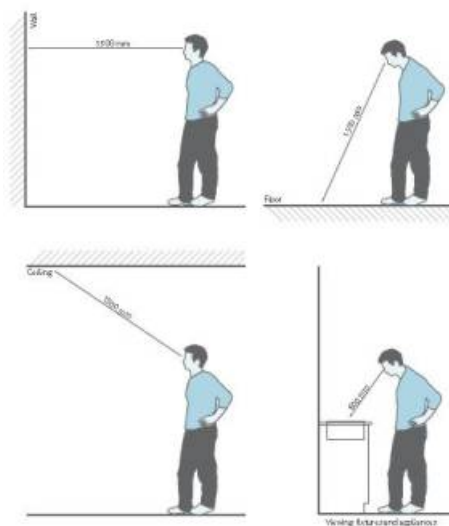
DIAGRAM F NORMAL VIEWING POSITIONS

Generally, variations in the surface colour, texture and finish of walls, ceilings, floors and roofs, and variations in glass and similar transparent materials are to be viewed where possible from a normal viewing position. A normal viewing position is looking at a distance of 1.5 m or greater (600 mm for appliances and fixtures) with the surface or material being illuminated by non-critical light<sup>1</sup>. Non-critical light means the light that strikes the surface is diffused and is not glancing or parallel to that surface.

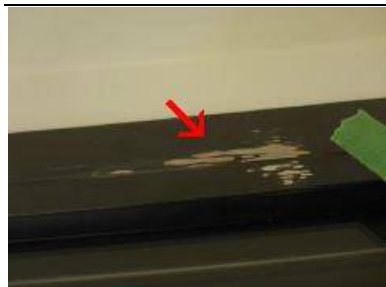
**Results:** The powdercoat finish is damaged to the frame section, which cannot be correctly repaired on site and will have to be replaced. Prior to aluminum being powder coated it must be chemically cleansed and etched to ensure correct adhesion and durability. This process is called Chemical Chromate Conversion. The aluminum is cleaned and rinsed in a series of tanks prior to being chemically etched. This final process applies a layer of Chromate as chemical protection, which gives the aluminium excellent corrosion resistance. Following this, the powder coat is applied using electrostatic spray equipment and baked at 180 - 200oC until cured. In attempting to effect an onsite repair, scratches and/or marks are rubbed with wet & dry sand paper. This involves rubbing through the powdercoat back to the aluminum, breaking through the corrosion protection layer and thereby nullifying the corrosive resistant' s of the aluminum. The area is then over-coated with an aerosol lacquer, which is an inferior product to the powdercoat and weathers differently to it. Acrylic lacquer is soft and offers only moderate durability to ultra violet, pollution and general dirt and grime. Also the layer of chromate has not been replaced, which greatly reduces the durability of the coating.

It should be noted that the door/Window manufacturer is exactly that - a manufacturer of door sections - and are not qualified or capable of repairing powdercoat finishes on site, which they often attempt to do, therefore all of the affected sections must be replaced with new ones.
